MATERIALS RESEARCH FOR THE CLEAN UTILIZATION OF COAL

QUARTERLY PROGRESS REPORT

October - December 1979

Center for Materials Science  
National Bureau of Standards  
Washington, D. C. 20234

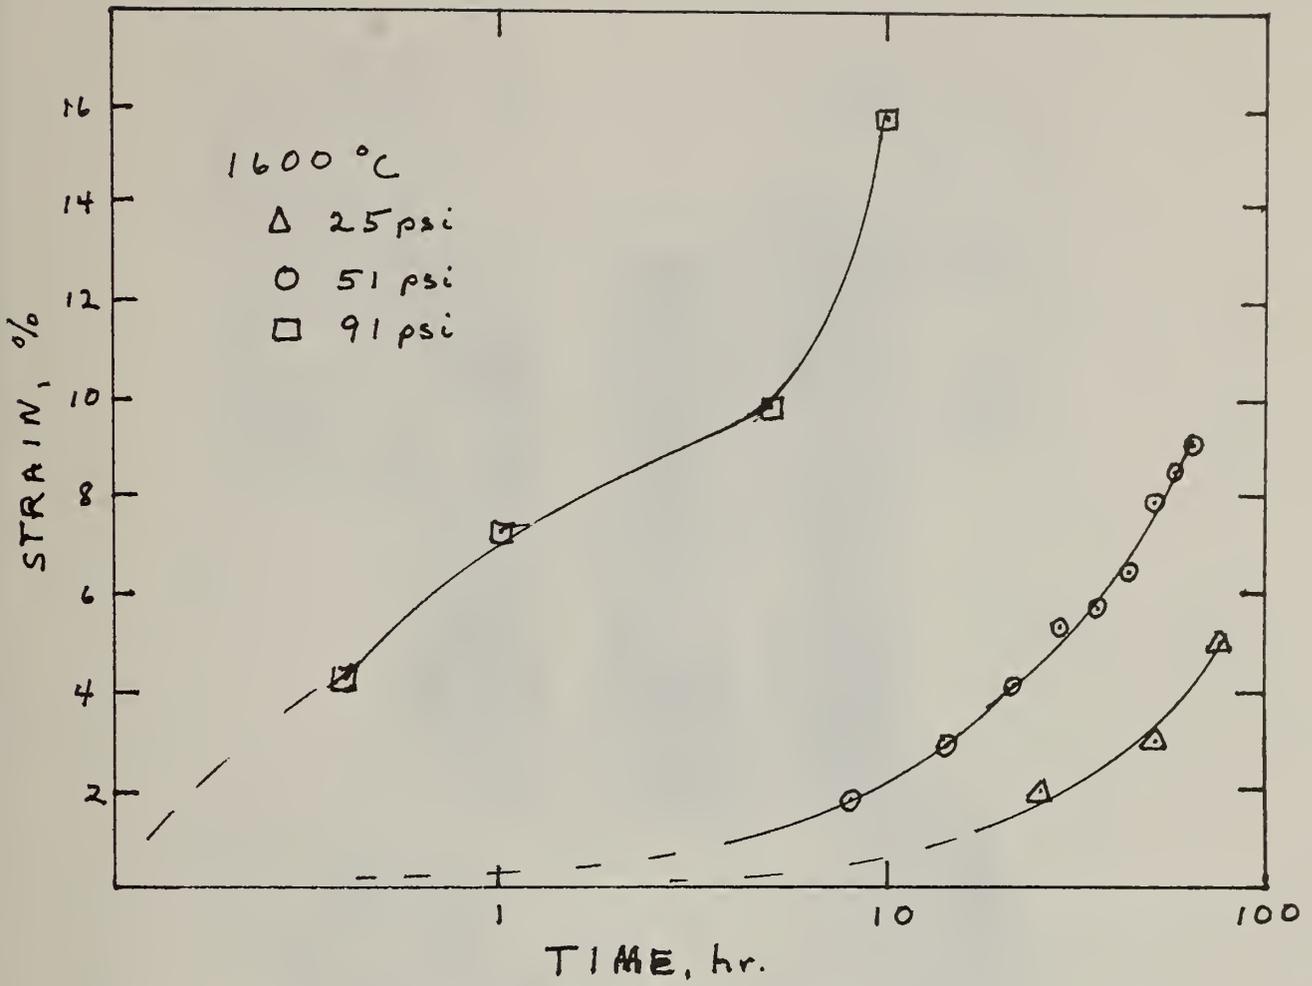
Fig. 1 Creep curves obtained under constant load conditions for the chrome spinel RFG refractory.

**Results:** The RFG refractory exhibited considerable creep at 1400 °C, 1500 °C and 1600 °C. Some of the data obtained from specimen measurements during loading are shown in Fig. 1. The plots show data obtained from the dilatometric measurements and from dimensional measurements of the specimen. The specimen tested at 91 psi at 1600 °C failed catastrophically in approximately 2 hours. The actual deformation of the specimens is shown in the light micrographs shown in Fig. 2. In these pictures, the cracking and swelling are seen clearly.

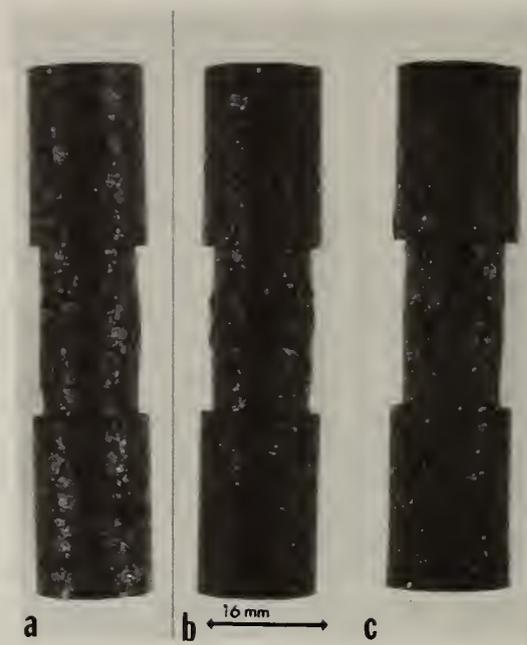
Fig. 2. Refractory RFG specimens from creep tests (a) 1400°C, 150 psi, 363 hr 7.5% deformation (b) 1500°C, 92 psi, 133 hr, 8.4% deformation (c) 1600°C, 51 psi, 63 hr 9.1% deformation.

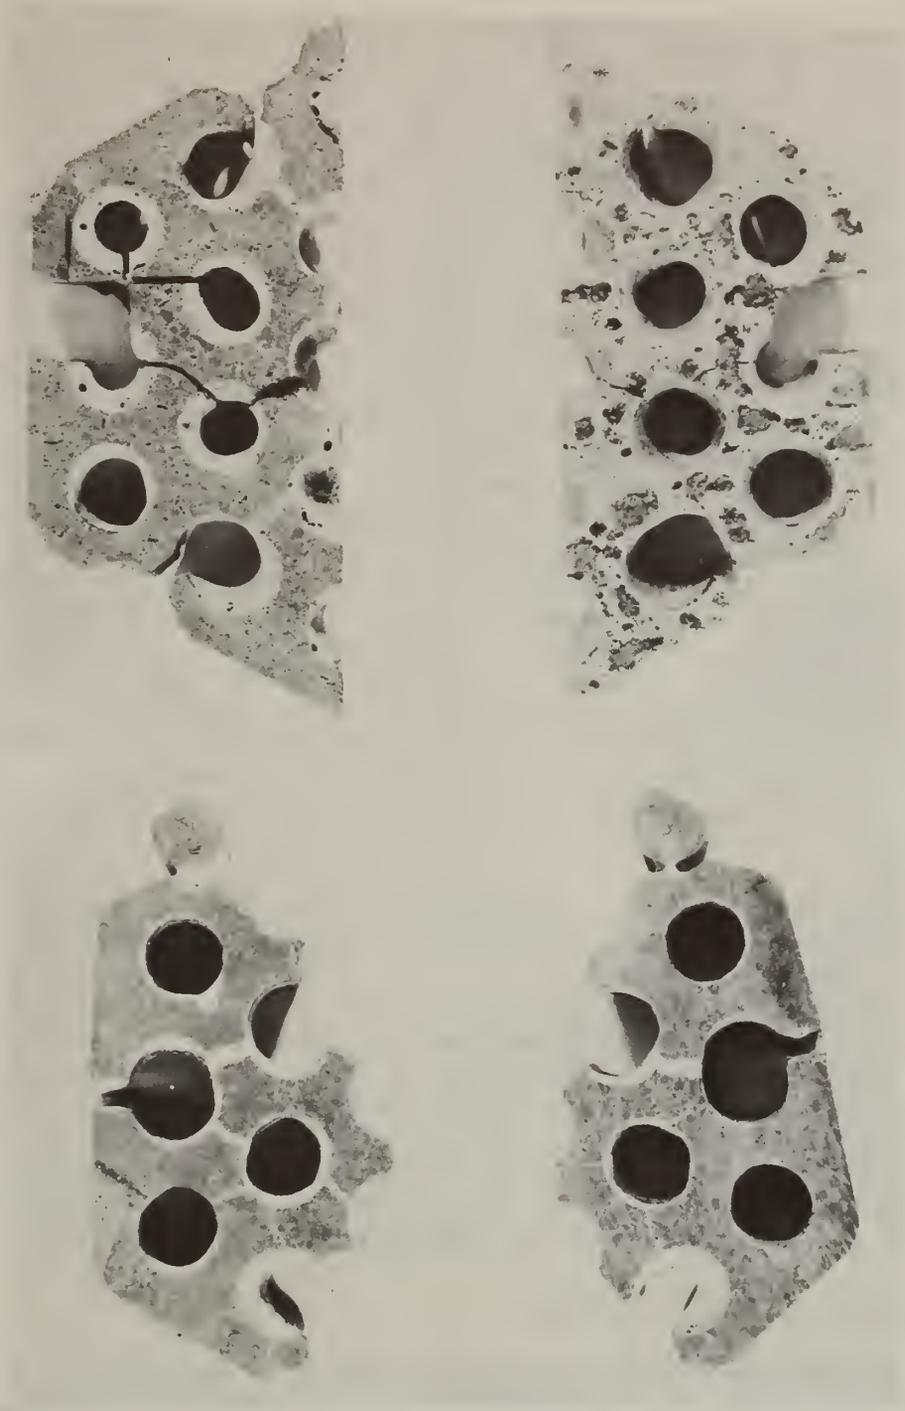
Fig. 3. Top and bottom surfaces of 1 in thick brick sections from Montana State test rig (a) brick 5-3 near top (b) brick 49-3, near bottom.

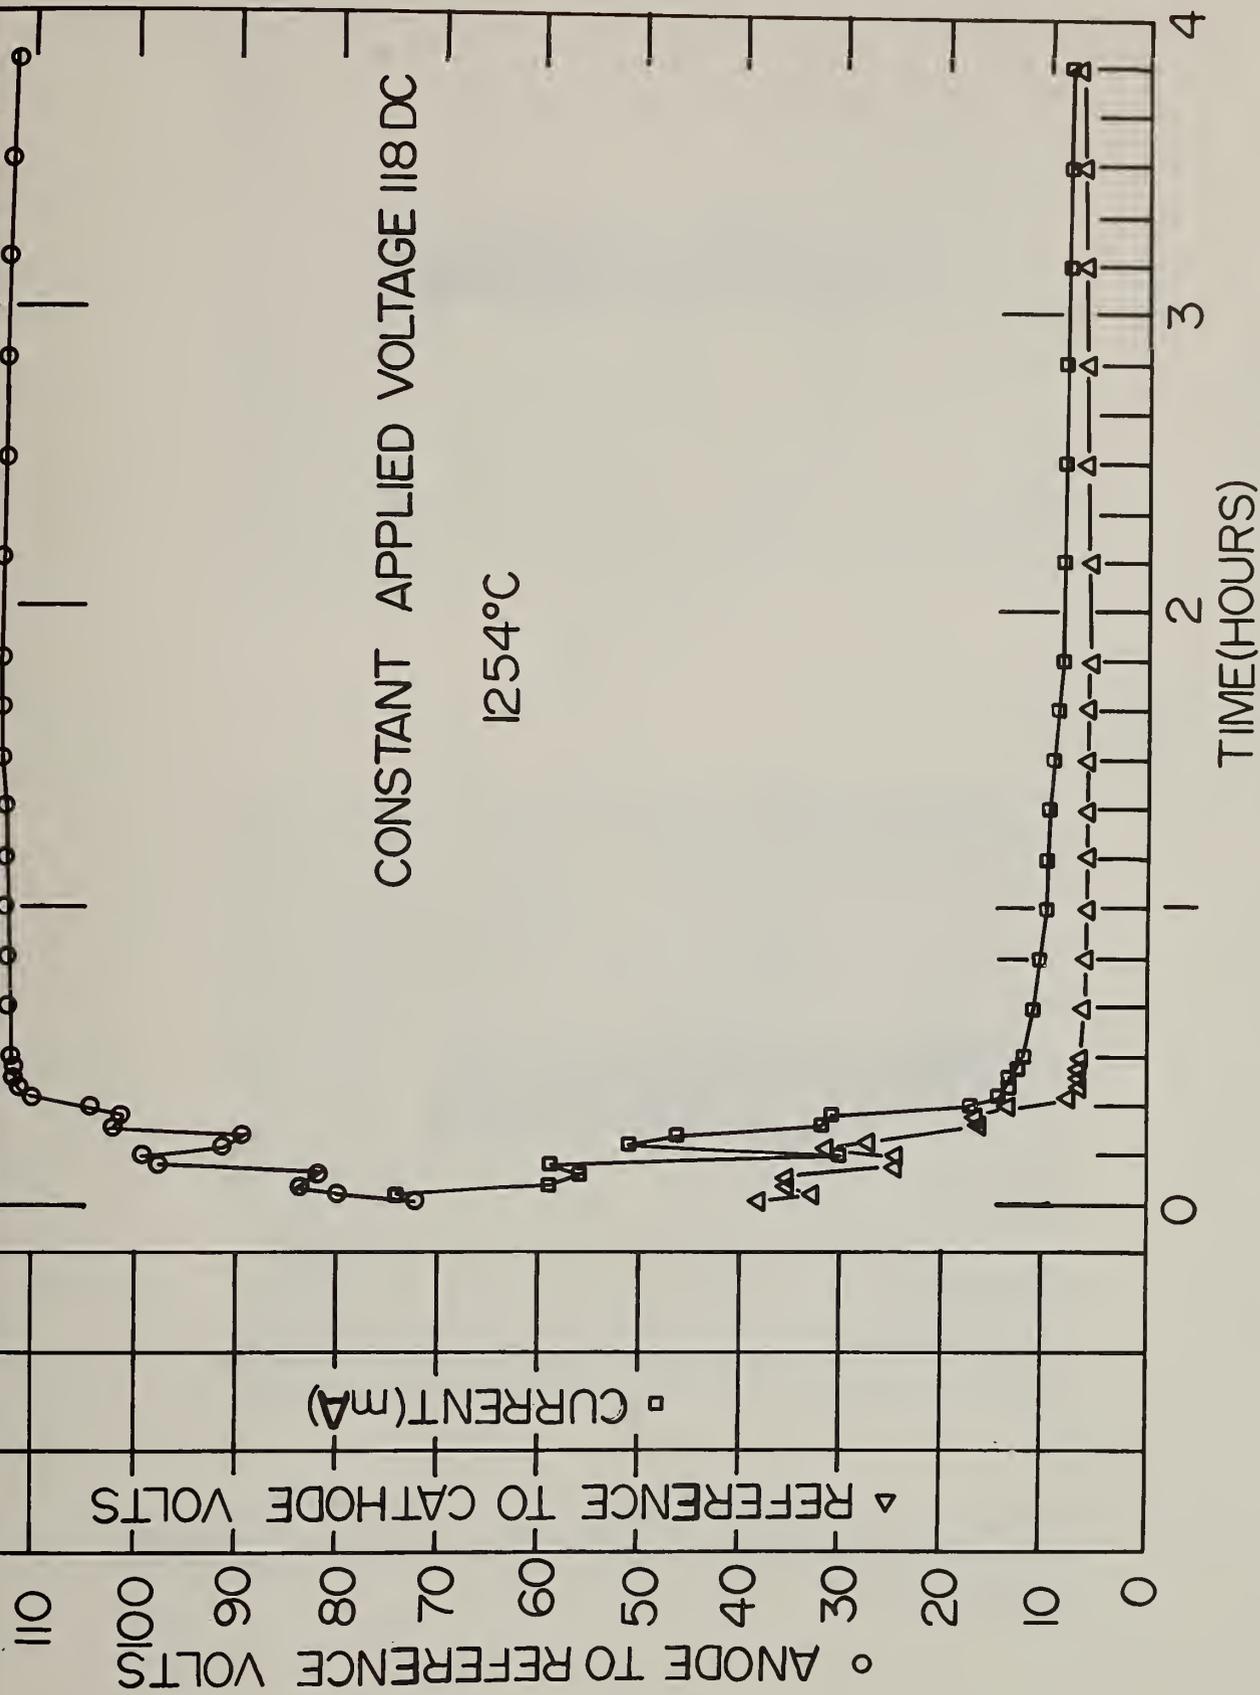
Figure 1. Time vs. voltage relationships in an electrochemical cell of  $Y_{.95}Ca_{.05}CrO_3$  in a slag electrolyte with added  $K_2SO_4$ .

In the last quarterly report, the results of a test on an electrochemical cell composed of  $YCrO_3$  electrodes and Bow NH slag with 20%  $K_2SO_4$  added were reported. This test was carried out at 1343 °C and resulted in considerable cathode reaction but with not much reaction at the anode. A new cell has been constructed and tested using the same materials (Bow NH slag with 20%  $K_2SO_4$  electrolyte and  $Y_{.95}Ca_{.05}CrO_3$  electrodes) but with a slightly different configuration. This cell contains 3 electrodes, two of which are active (anode and cathode at each end of the cell) and one which is passive (center of cell) which carries no current. This allows for direct measurement of the potential distribution along the length of the cell i.e. for potentials between

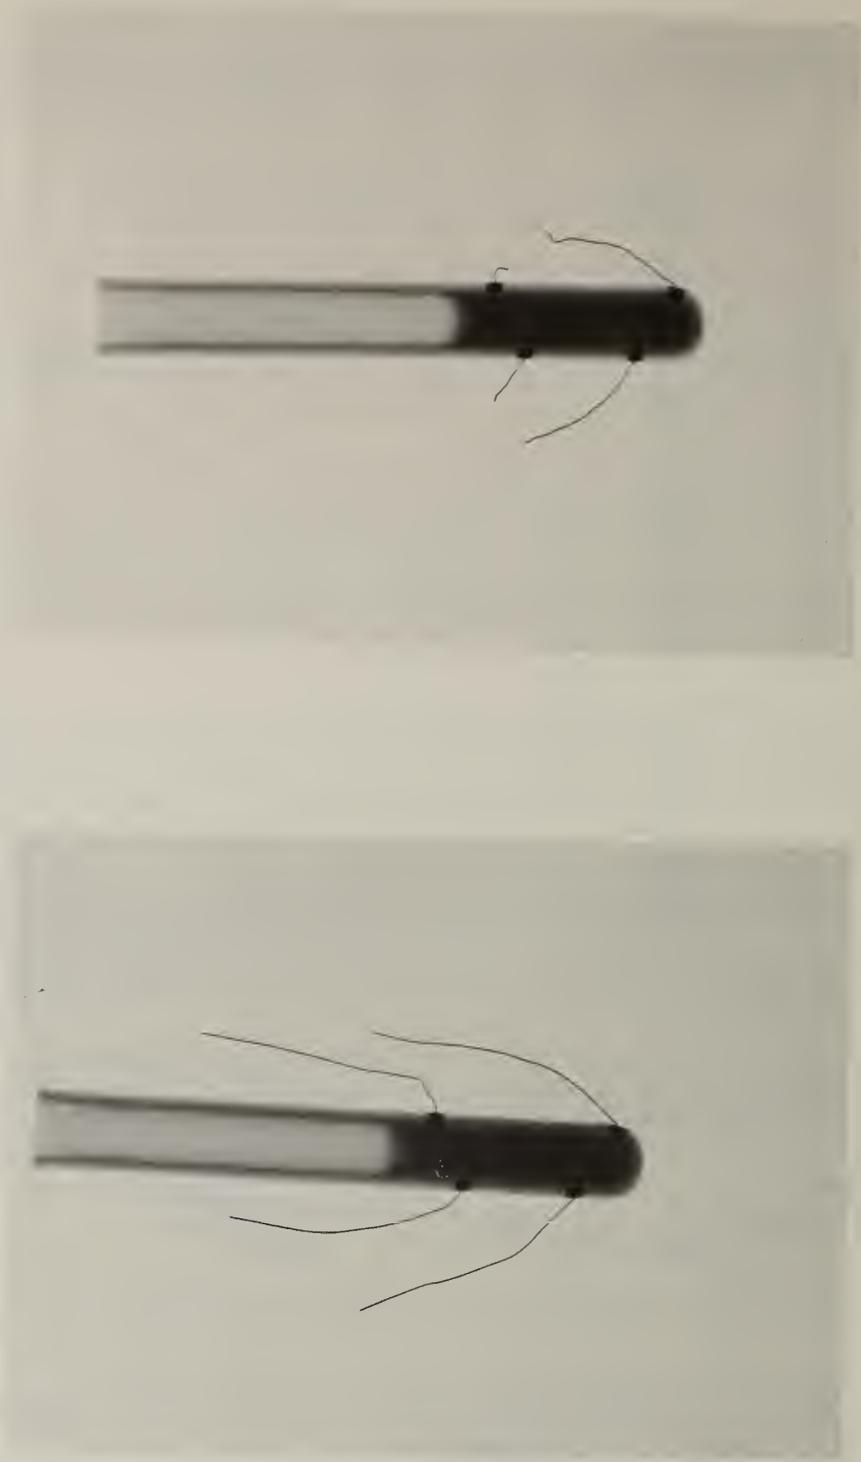
Figure 2. Radiograph of crucible showing slag fill and electrode configuration before (a) and after (b) electrical conductivity measurements.

The electrical conductivity of Bow NH slag with 20% K<sub>2</sub>SO<sub>4</sub> added to the melt has been completed. Figure 2a and b show radiographs of the crucible containing the slag before and after the experiment. No observable physical change has taken place during the experiment. Figure 3 shows the conductivity data as a function of temperature. All data was taken at a partial pressure of oxygen of 2 x 10<sup>-6</sup> atmospheres. The temperature from which the slag was furnace quenched to 900°C is indicated on the graph. The conductivity data at reduced oxygen pressure is not quite so quench temperature dependent as that data for the conductivity in air shown in the last quarterly report (July-Sept. 1979). The magnitude and the general trend is the same, however. There appears to be two

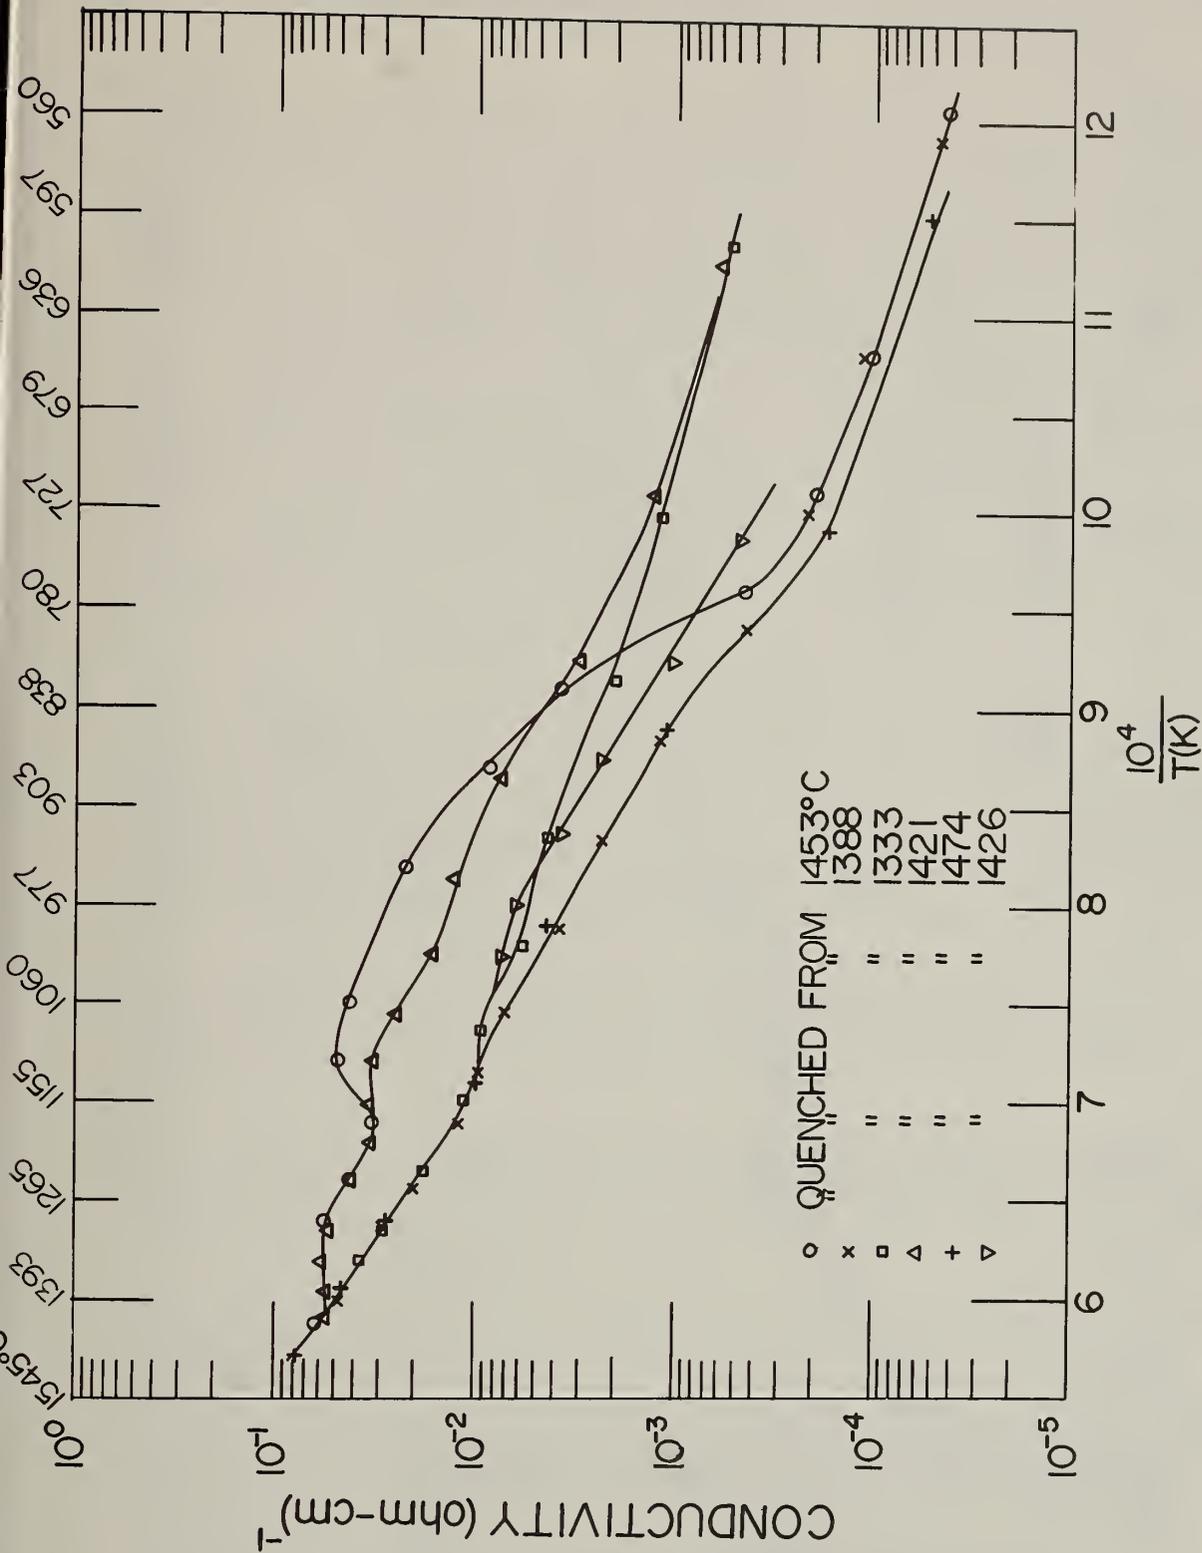
Figure 3. Electrical conductivity of Bow NH slag with 20%  $K_2SO_4$  added to the melt. All data was taken in  $2 \times 10^{-6}$   $O_2$  atmospheres in  $N_2$  and with increasing temperature after being quenched to 900°C from the equilibration temperatures indicated on the graph.

crystalline phases contributing to the conductivity. In the reduced  $O_2$  pressure experiment, a break in the conductivity curve occurs near  $1160^\circ C$  for all data; the break becoming more pronounced for the runs where the sample is quenched to  $900^\circ C$  from soak temperatures above  $1400^\circ C$ . All data shown on the graph is taken with increasing temperature after being quenched to  $900^\circ C$  and cooled slowly to the lower temperature ( $\sim 500^\circ C$ ). The data below  $800^\circ C$  may be affected by cracks in the slag body formed by quenching to  $900^\circ C$  and subsequent cooling to lower temperatures. Cracking appears to be more severe in those samples with the  $K_2SO_4$  added. It would be interesting to see how the coefficients of thermal expansion for these seeded and unseeded slags differ. X-Ray diffraction measurements (courtesy of H. Parker, Center for Materials Science, Solid State Chemistry Group) show that the phase composition below  $1180^\circ C$  is a kalsilite like phase (probably  $KAlSiO_4$ ) and spinel ( $Fe_3O_4$ ) for that material quenched from  $1426^\circ C$ . This kalsilite like phase was not detected in the slag measured in an air atmosphere and quenched from nearly the same temperature ( $1420^\circ C$ ). The spinel ( $Fe_3O_4$ ) was detected in the sample measured in air. The interesting and unusual aspect is that the slag conductivities for Bow NH slag with and without seed and measured in air and in an atmosphere of  $2 \times 10^{-6} O_2$  partial pressure are the same as a function of temperature above  $1400^\circ C$ . If the potassium ion conductivity is the predominant mechanism for charge transport, above  $1400^\circ C$ , the samples containing added  $K_2SO_4$  should have a higher conductivity. Chemical analysis for K and S of the Bow NH slag with 20 wt.%  $K_2SO_4$  added to the melt before and after the electrical measurement ( $2 \times 10^{-6}$  atmos  $O_2$ ) are given in Table 1.

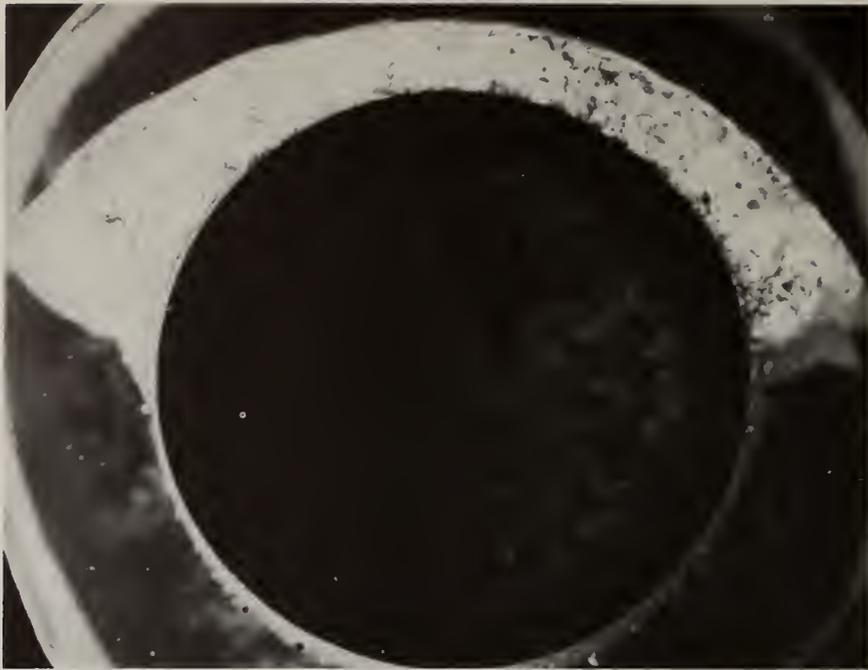
Fig. 1. Section of Type 304 stainless steel tubing after exposure to  $K_2CO_3/K_2SO_4$  seeded oxygen rich hot gas stream. Note formation of thick deposit, 1.7 mm, on upper surface and thin powdery deposit on lower surface. Tube temperature 400°C. 6 X.

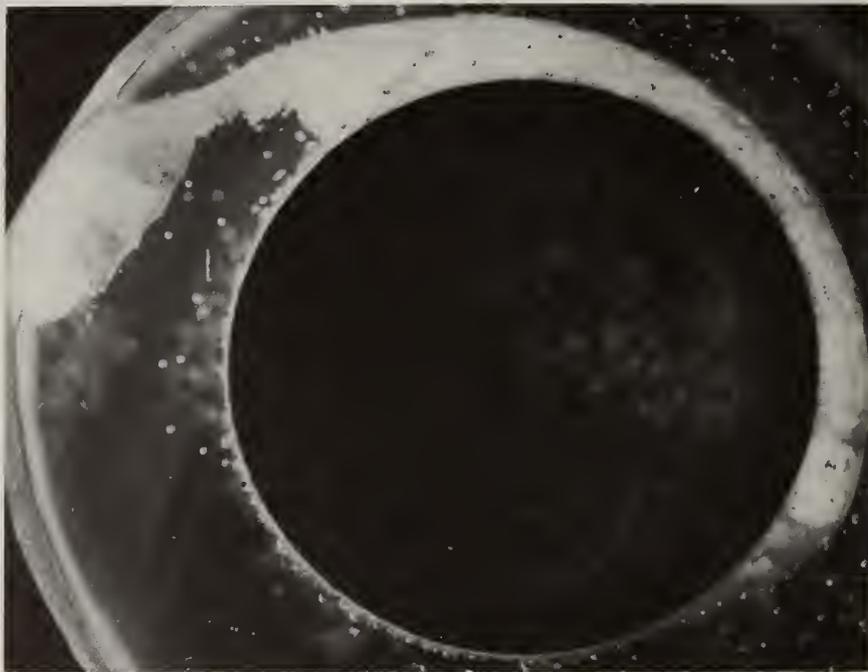
Fig. 2. Section of Type 304 stainless steel tubing after exposure to  $K_2CO_3/K_2SO_4$  seeded oxygen rich hot gas stream. Note formation of thick deposit, 1 mm on upper surface. Tube temperature 500°C. 6 X.

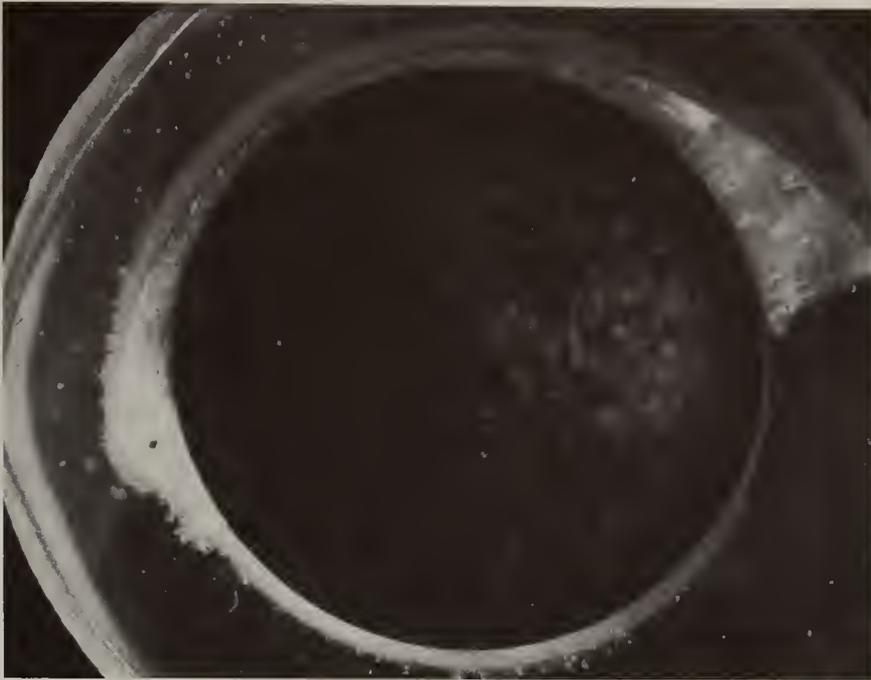
Fig. 3. Section of Type 304 stainless steel tubing after exposure to  $K_2CO_3/K_2SO_4$  seeded oxygen rich hot gas stream. Note formation of thinner deposit on upper surface. Tube temperature  $590^\circ C$ . 6 X.

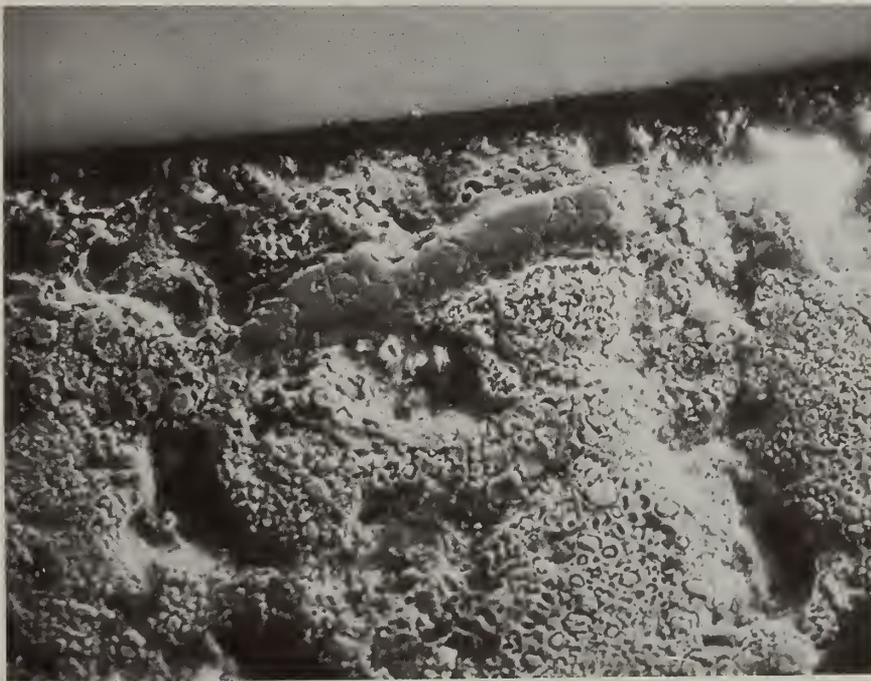
Fig. 4. SEM micrograph, 200 X, of small, high potassium concentration nodes in the salt deposit. Specimen temperature  $400^\circ C$ ; gas stream oxygen rich.

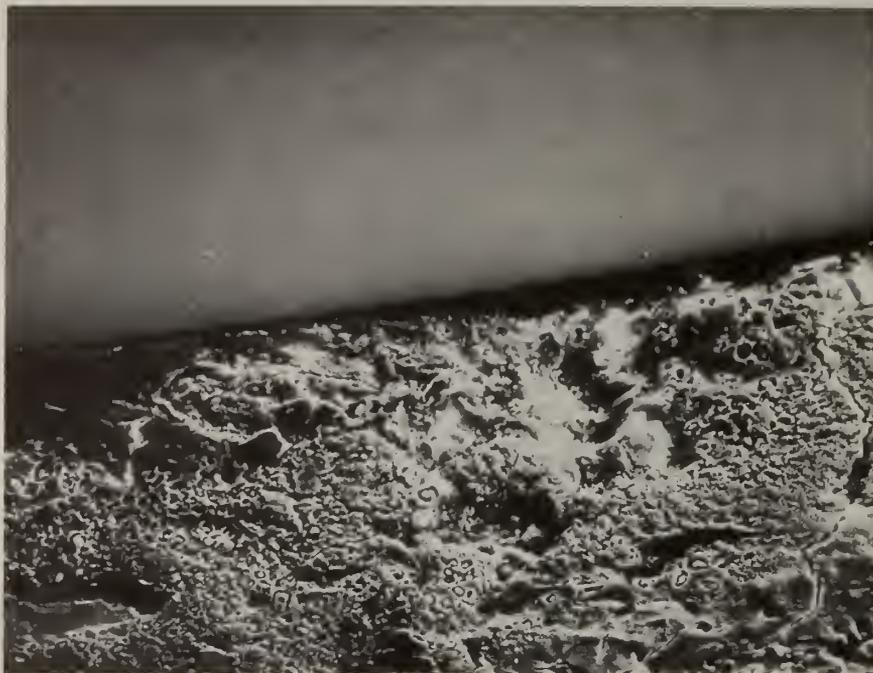
Fig. 5. SEM micrograph, 200 X, of small, high potassium concentration nodules in the salt deposit. Specimen temperature 500°C; gas stream oxygen rich.

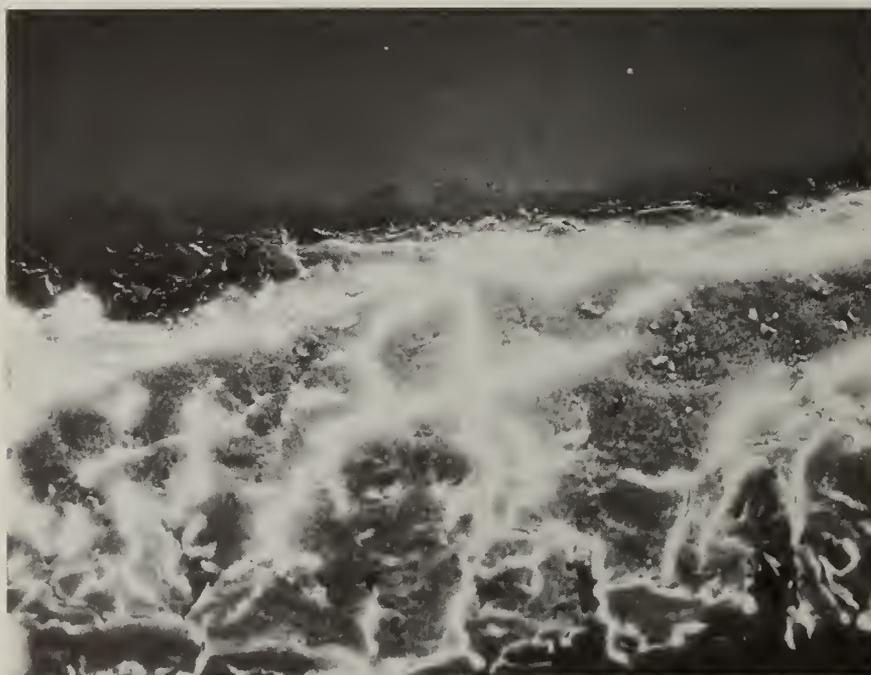
Fig. 6. SEM micrograph, 200 X, of salt deposit showing absence of high potassium concentration nodules. Specimen temperature 590°C; gas stream oxygen rich.

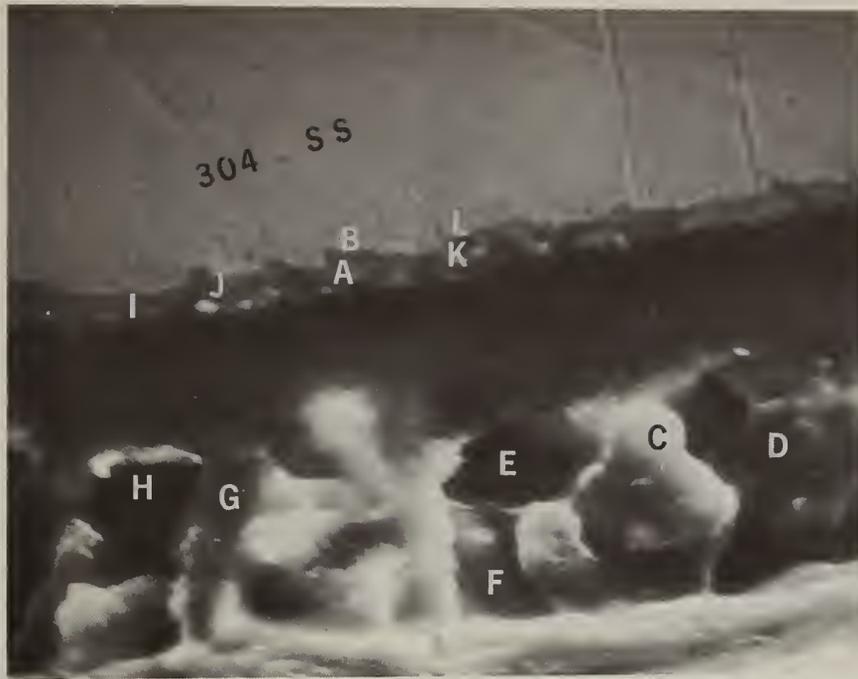
Fig. 7. SEM micrograph, 2000 X, of stainless steel-salt deposit reaction zone. Lettered regions correspond to labeled EDX spectra, figures 7a through 7f. Specimen temperature 500°C; gas stream oxygen rich.

The corrosion band area on the 304 stainless steel increases with increasing temperature. The variation in corrosion can be observed in the comparison of Figure 7 (specimen temperature 500 °C) with Figure 8) specimen temperature 590 °C). SEM/EDX analysis of both samples, Figures 7a-7g and Figures 8a-8j, indicate metal corrosion and metal cation migration, however, the 590 °C specimen shows the corrosion picture more vividly.

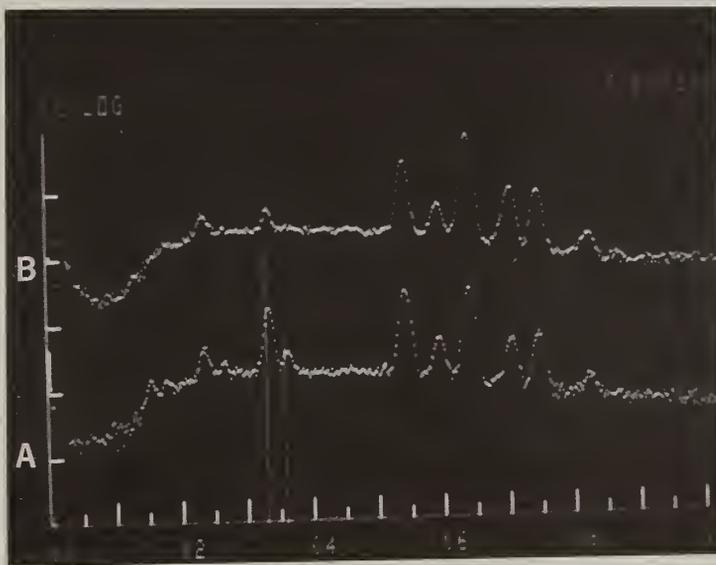
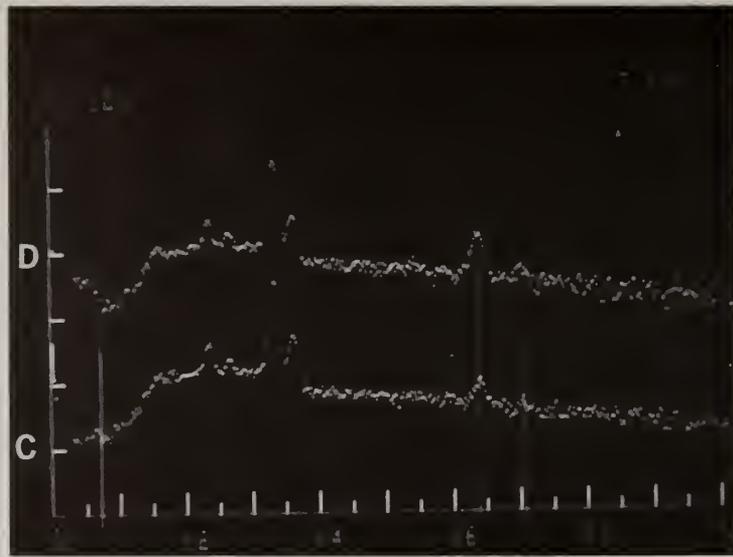
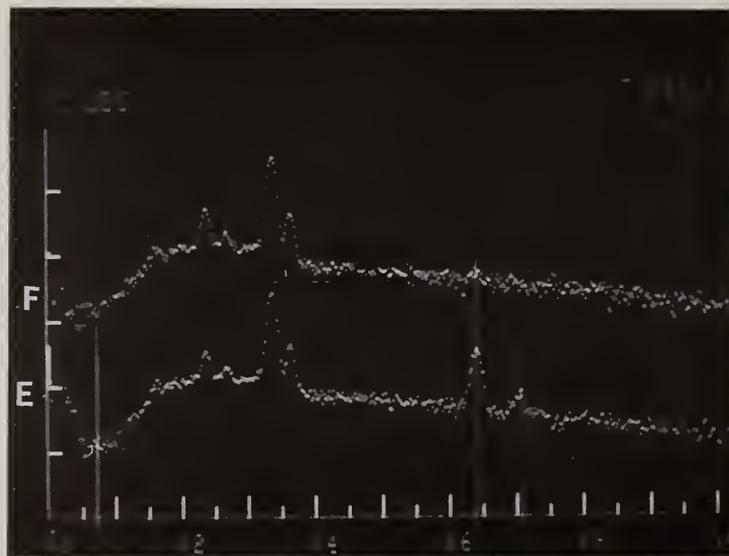
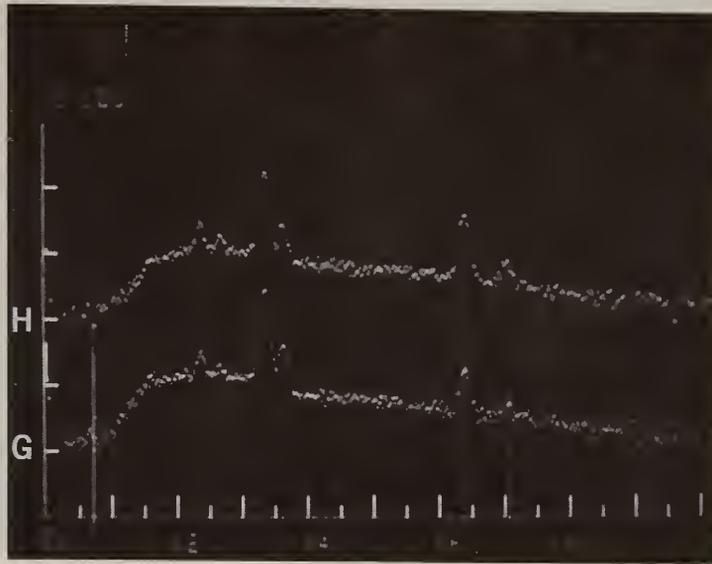
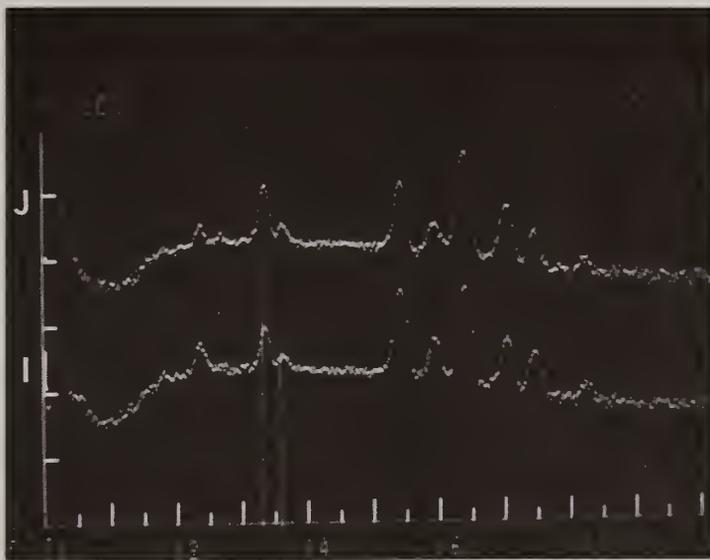
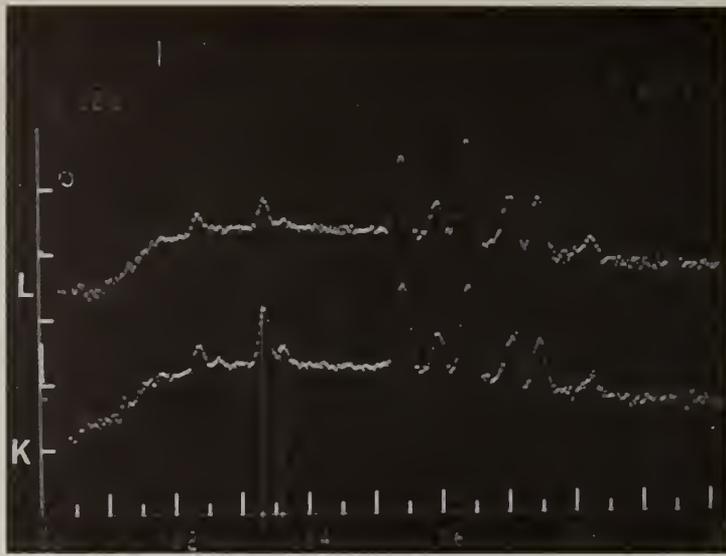
Fig. 7a. EDX spectra of regions A and B of figure 7 showing high Cr concentration area.

Fig. 7b. EDX spectra of regions C and D of Fig. 7 showing region of high potassium concentration associated with Fe in the salt region of the corrosion area.

Fig. 7c. EDX spectra of regions E and F of Fig. 7 showing Fe penetration in the salt.

Fig. 7d. EDX spectra of regions G and H of Fig. 7 showing Fe penetration in the salt.

Fig. 7e. EDX spectra of regions I and J of Fig. 7 showing areas of high Cr and low Ni concentration.

Fig. 7f. EDX spectra of regions K and L of Fig. 7 showing areas of high Cr concentration formed on stainless steel edge.

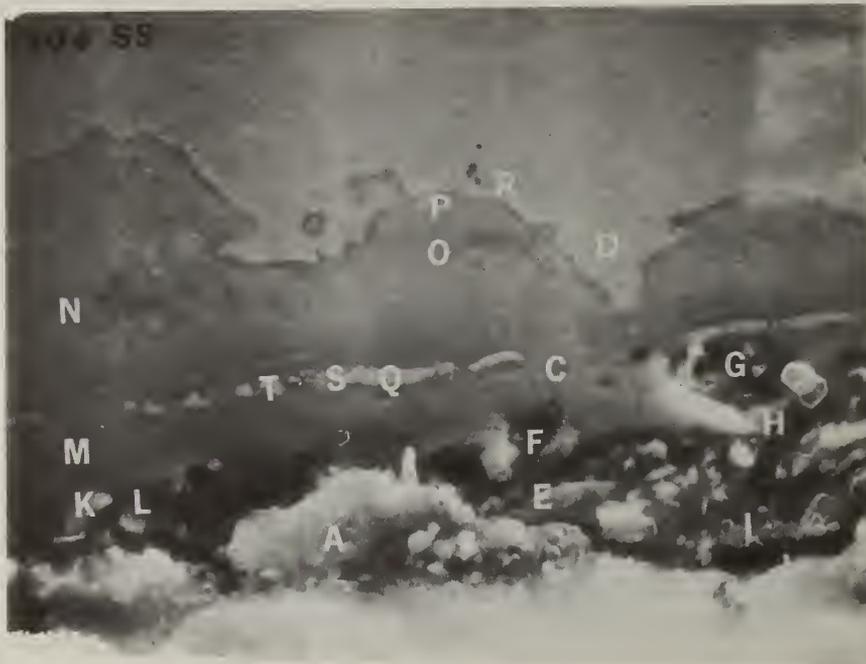
Fig. 8. SEM micrograph, 2000 X, of stainless steel-salt deposit reaction zone. Lettered regions correspond to labeled EDX spectra, Figs. 8a-8j. Specimen temperature 590°C; gas stream oxygen rich.

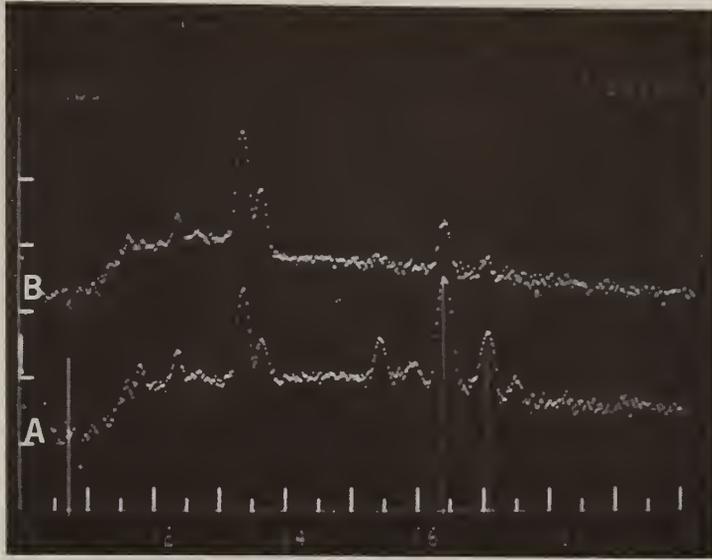
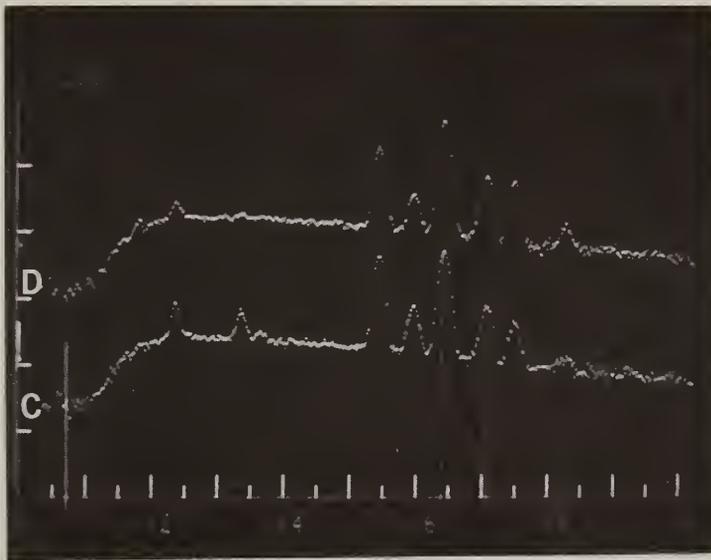
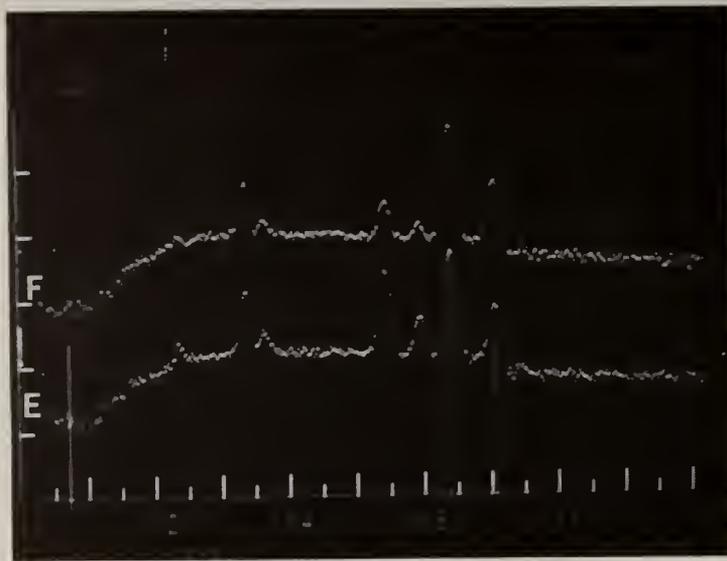
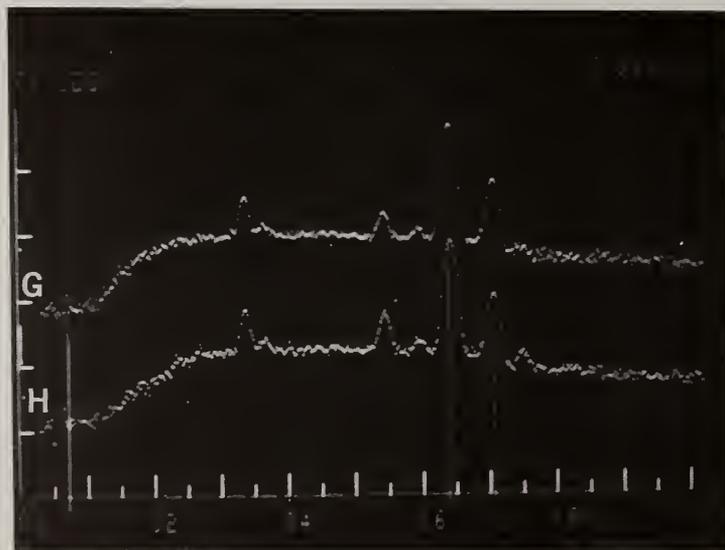
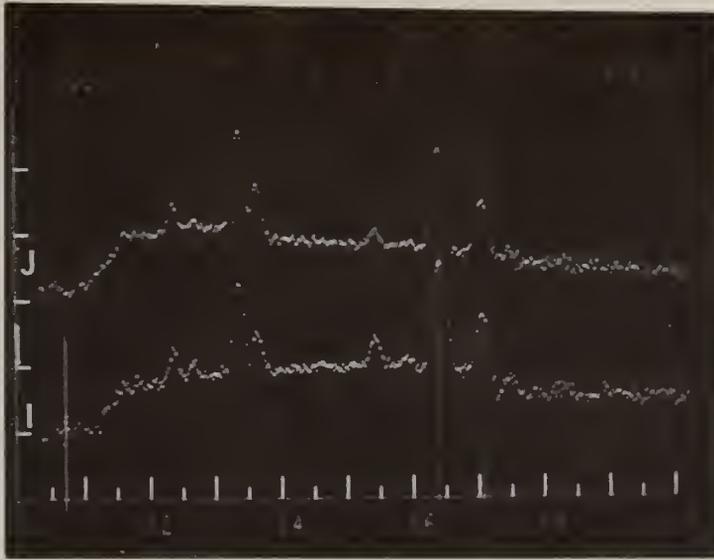
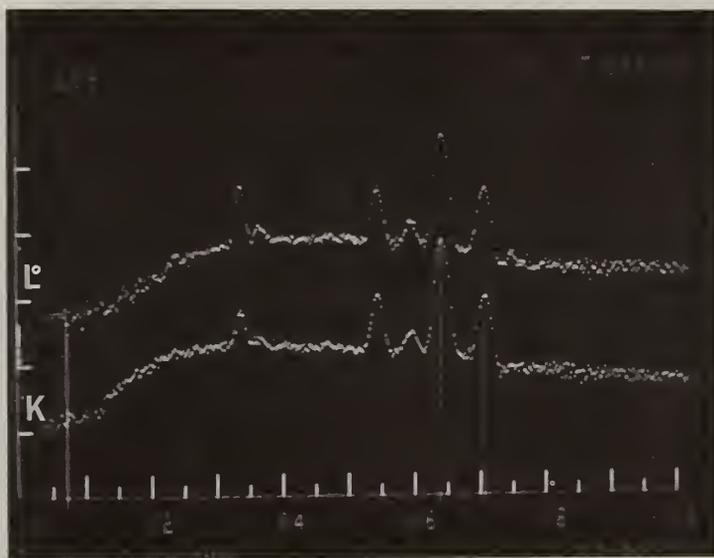
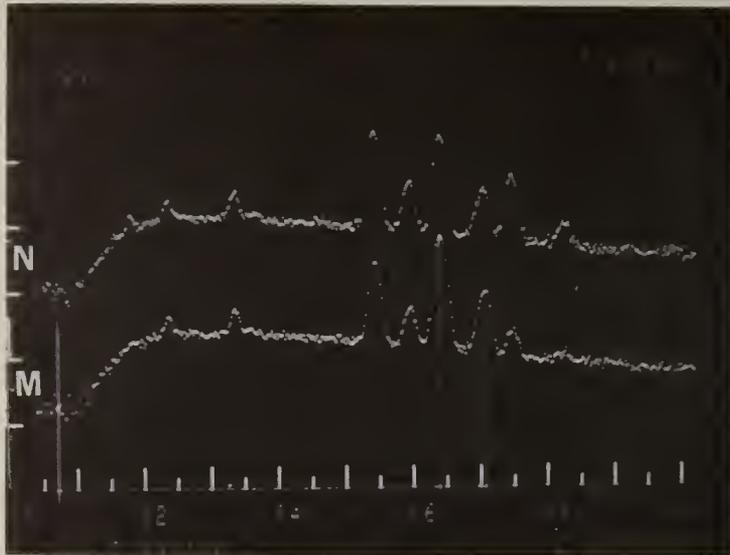
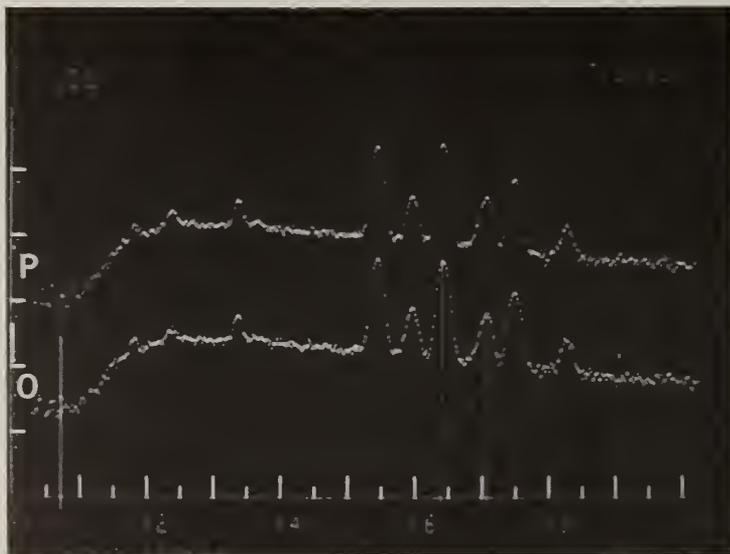
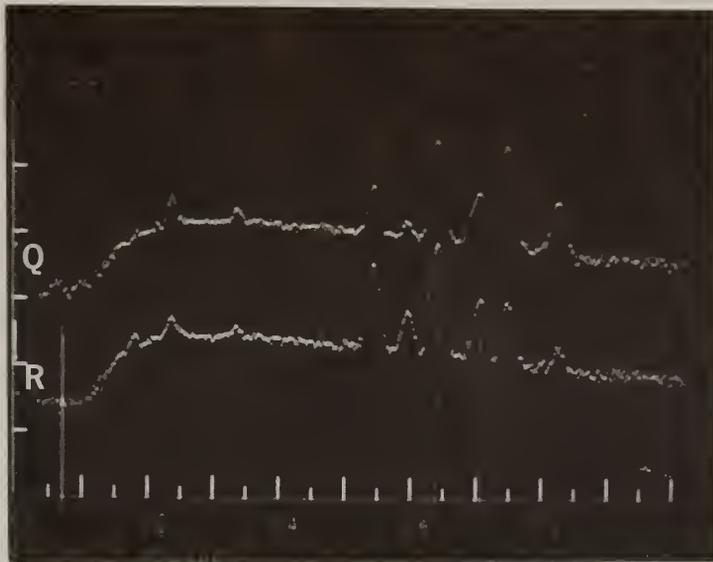
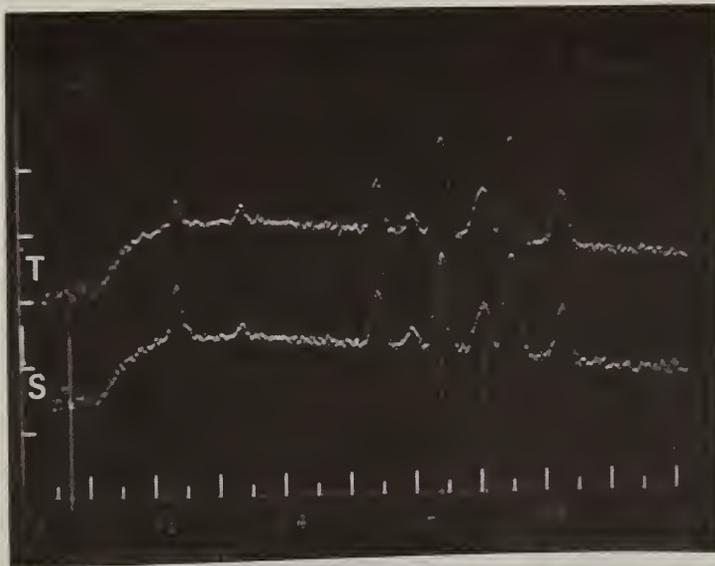
Fig. 8a. EDX spectra of regions A and B of Fig. 8 showing Fe penetration in the salt deposit.

Fig. 8b. EDX spectra of regions C and D of Fig. 8 showing area of high Cr concentration as compared to bulk stainless.

Fig. 8c. EDX spectra of regions E and F of Fig. 8 showing area of high Cr and high Fe concentration with absence of Ni at the stainless steel-salt interface.

Fig. 8d. EDX spectra of regions G and H of Fig. 8 showing area of high Fe and low Cr concentration with traces of Ni at the stainless steel-salt interface.

Fig. 8e. EDX spectra of regions I and J of Fig. 8 showing penetration of Fe and Cr in the salt deposit.

Fig. 8f. EDX spectra of regions K and L of Fig. 8 showing area of high Fe and low Cr concentration with absence of Ni at the stainless-steel salt interface.

Fig. 8g. EDX spectra of regions M and N of Fig. 8 showing areas of high Cr and high Ni concentration as compared to low Cr and low Ni below the stainless steel-salt deposit interface but within the reaction band.

Fig. 8h. EDX spectra of regions O and P of Fig. 8 showing areas of high Cr and high Ni concentration below the stainless steel-salt deposit interface, but within the reaction band.

Fig. 8i. EDX spectra of regions Q and R of Fig. 8 indicating a region of very high Ni concentration in a matrix of high Cr concentration as compared to the bulk stainless steel.

Fig. 8j. EDX spectra of regions S and T of Fig. 8 showing high Ni concentration with the high Cr concentration matrix.

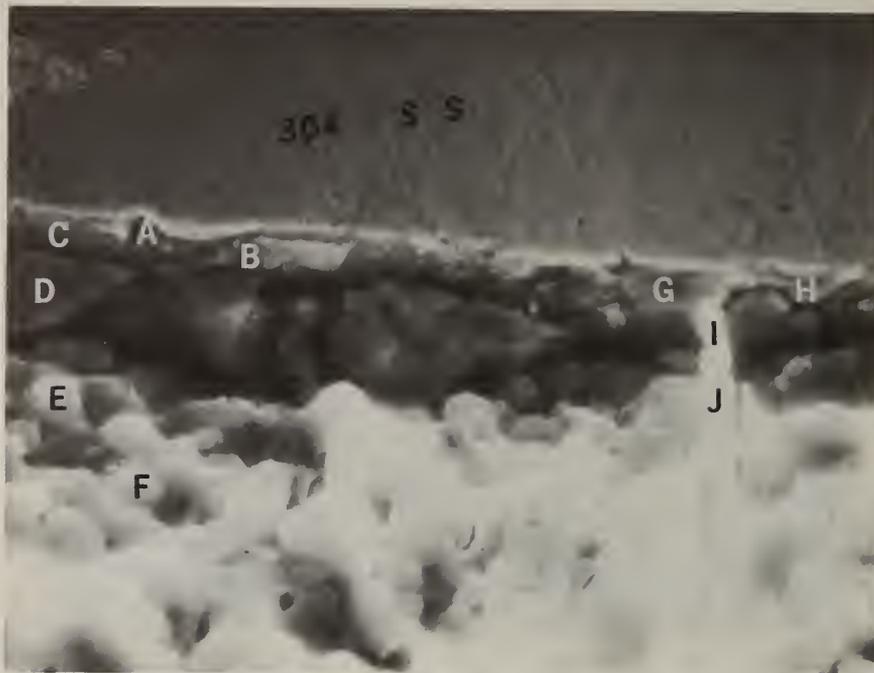
Fig. 9. SEM micrograph, 2000 X, of stainless steel-salt deposit reaction zone. Lettered regions correspond to labeled EDX spectra Figs. 9a-9e. Specimen temperature 400°C; gas stream oxygen rich.
